Overview:

In the December 2007 annual meeting, Fenway Garden Society President, Tim Horn, targeted three major capital improvements as part of his agenda, including revamping the crumbling irrigation system. Now, the new irrigation project is complete, and ready to hook up this spring.

With the help of a grant from the New England Grass Roots Environmental Fund, and generous member contributions, the Fenway Garden Society has completely replaced the obsolete underground cast iron irrigation water main system with a modern, modular system that will save hundreds of thousands of gallons of water and thousands of dollars in city expenses.

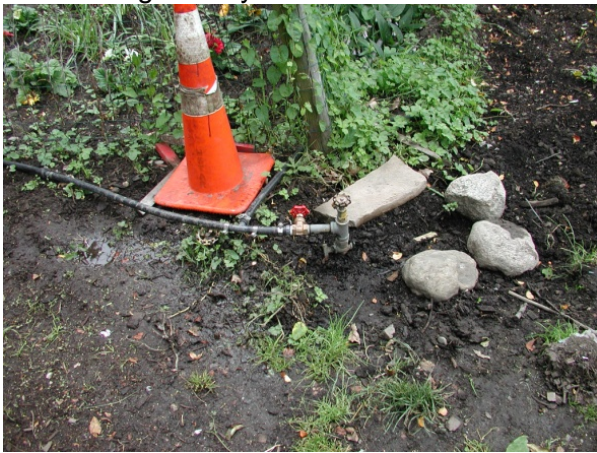
The old irrigation system

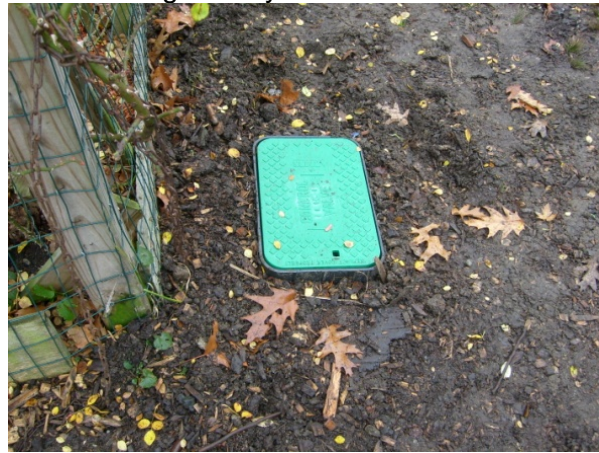
The new irrigation system

The new system has a box for almost every row, and every row has its own shut off valve. Each section has an isolation valve as well. This means that if there is ever a leak within one row, that row can be individually shut down while repairs are made to the 'push and clamp' black irrigation row pipes. Most rows have an extra feed in their box so gardeners in a row with a problem can use the row's spare valve, right off of the main, without hiking to the flag-pole.

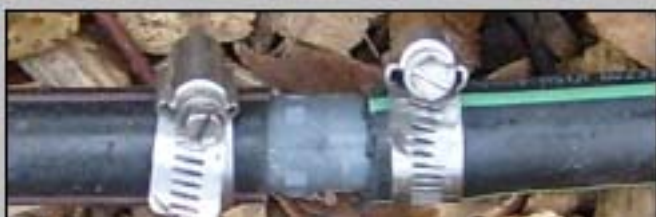
1. Shut off the row, using the valve in the green box at the end of the row.
2. Unscrew the hose clamp on each side of the bad pipe and remove black pipe from barb.
3. Cut black pipe with a hand saw if removal at join is not practical.
4. Place a hose clamp over the end of the new piece of black pipe.
5. Push black pipe over barb and tighten hose clamp.

6. Turn on water at row valve to be sure you fixed the leak.
